Manhole Inspection Summary

Manhole # S09QQ1033MH

Location Address: **5018 PALMER AVE** Cross Street: **SPAULDING AVE**

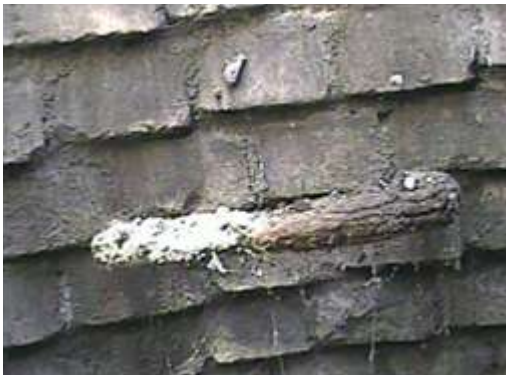
Defect 1

Steps Count: **3** Missing: **0** ☒ **Corroded**

CORRODED RUNG

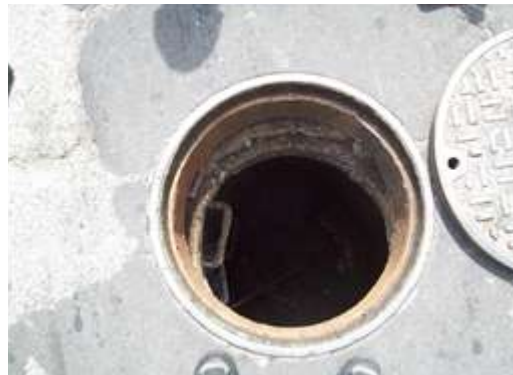
Defect 3

Frame Offset: **4** (in.) Condition: ☒ Sound ☐ Cracked ☐ Leaks

FRAME OFFSET

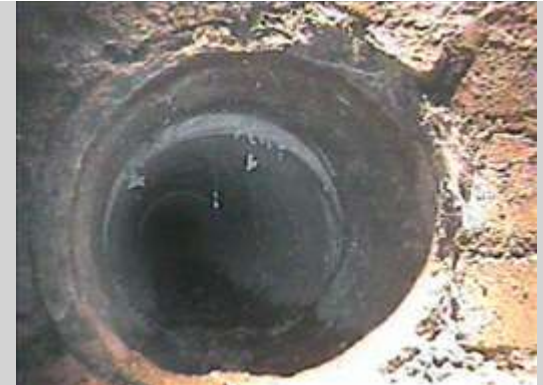
12 O'Clock Outflow

10 in. Circular Gravity Sewer
Pipe Out @ 12 O'Clock

Pipe Material: **Clay** ☐ Pipe Lined

Invert Depth: **7.42** (ft.) Flow Characteristics: **None**

Silt Depth: **0.5** (in.) Deposits Extent: **Light**

Infiltration: **None** Pipe Seal Cond: **Sound**

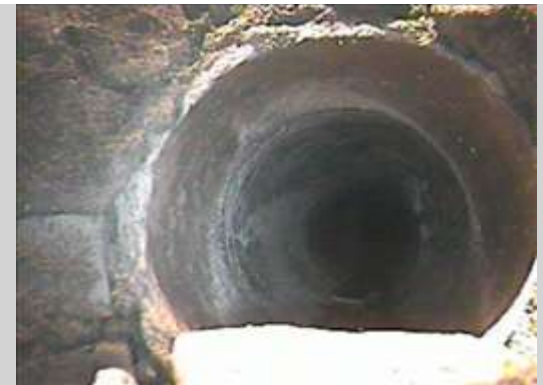
6 O'Clock Inflow

10 in. Circular Gravity Sewer
Pipe In @ 6 O'Clock

Pipe Material: **Clay** ☐ Pipe Lined

Invert Depth: **7.58** (ft.) Flow Characteristics: **None**

Infiltration: **None** Pipe Seal Cond: **Sound**
